**Land at Peel Hall, Warrington  
Access Strategy (Provision of or Modifications to 12 Junctions)  
Road Safety Audit Stage 1**

**Report No 16/2018**

**January 2018**

***Alan Consultancy Ltd  
Road Safety and Traffic Consultants***

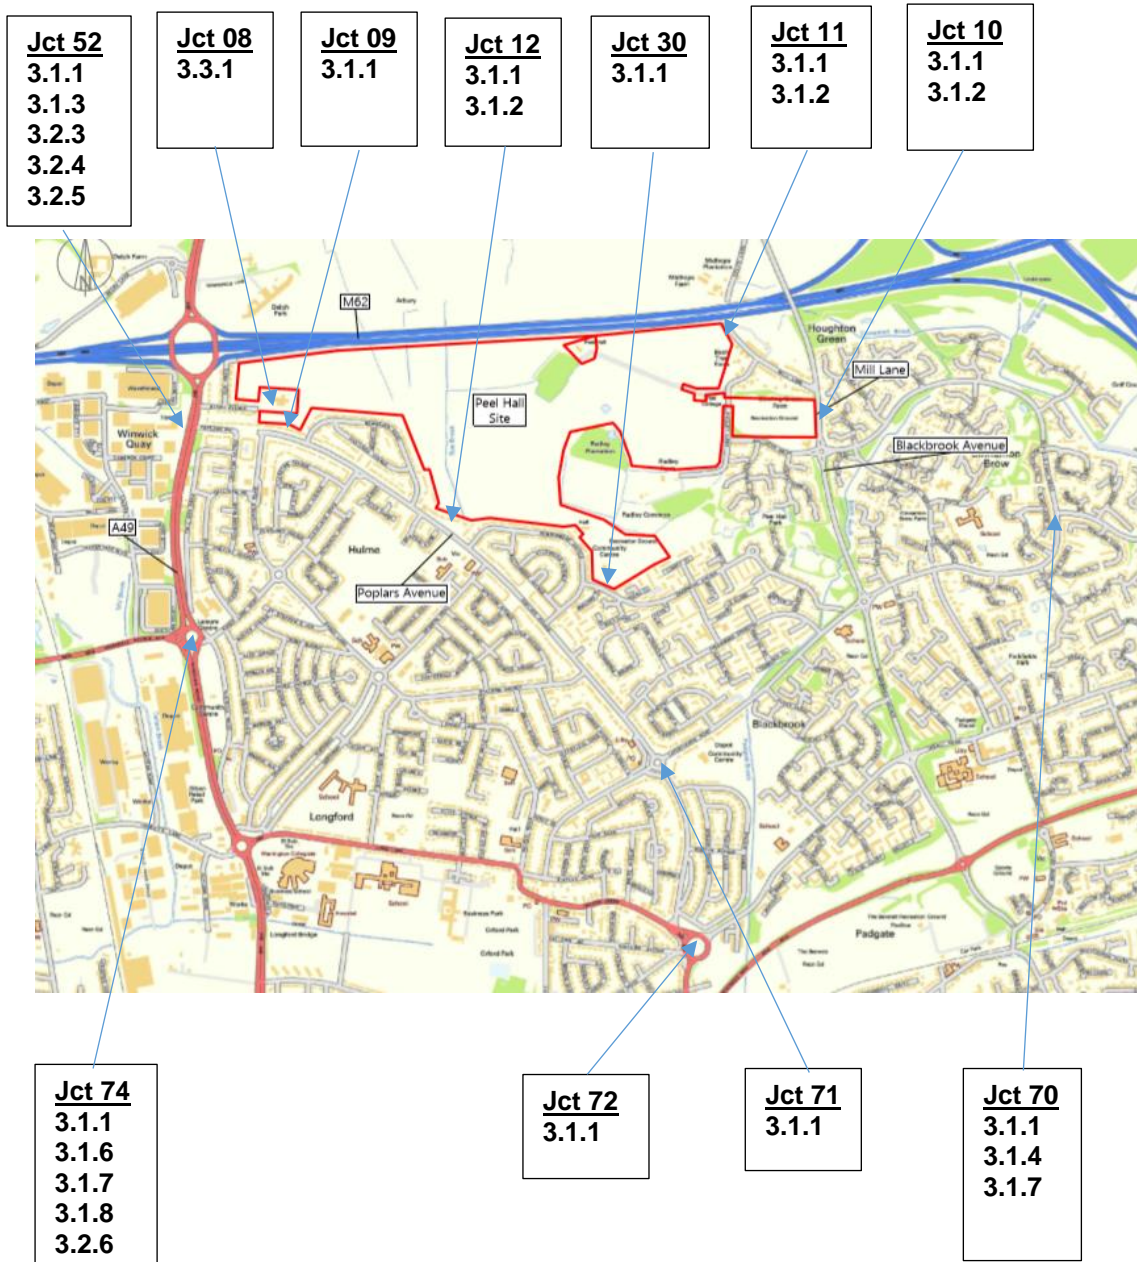
## Reference Plan

1.5 All comments and recommendations are referenced to the preliminary design drawings and the locations are indicated on the attached A4 plan.
